WINDOWS NUMBER 10

Temporary Window Vents in Unoccupied Historic Buildings

WORTHINGTON HOUSE Monocacy National Battlefield Frederick County, Maryland

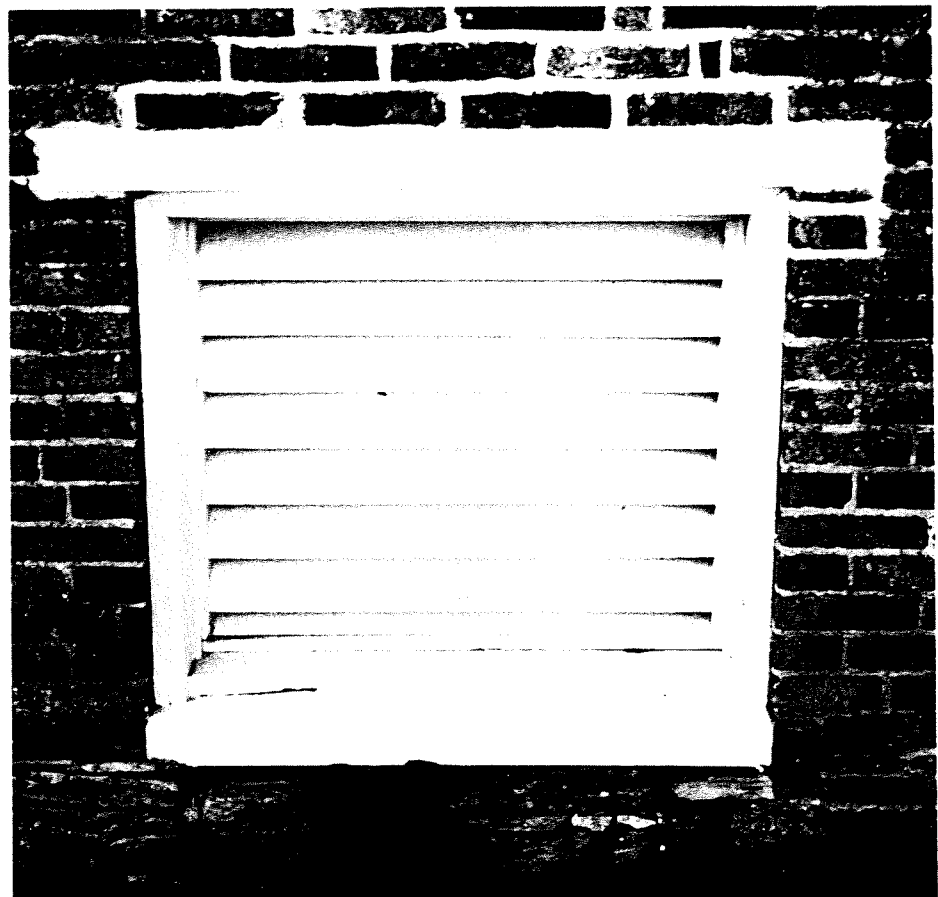
Figure 1. Full louvered vents were installed in all single-sash openings in the basement because of the more severe moisture problems present in that location. Photo: Charles Fisher

Wooden fixed louver vents were custom-made and installed. The easily fabricated louvers were sized to fit the lower sash opening — 34½" wide by 34¼" high on the first floor, while those for the smaller second floor windows were only 25¼" high. Full units were installed in all single-sash basement windows, since the window area was much less and the moisture problems more severe (see figure 1). At the same time, the three attic windows were also replaced with full louvers to encourage thorough multi-level ventilation.

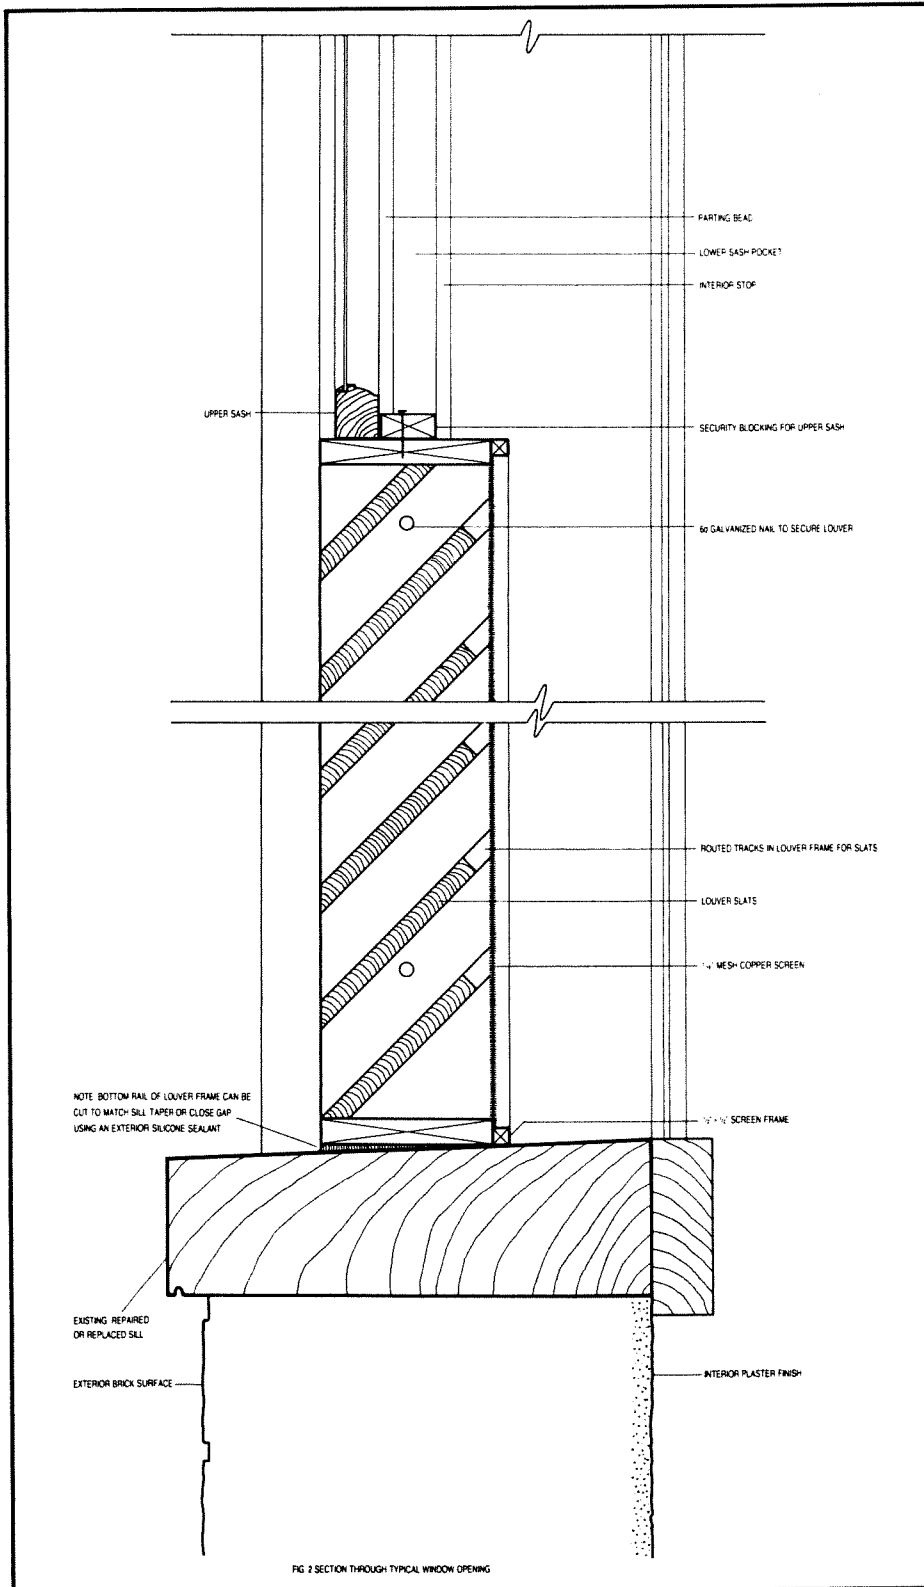
Figure 2. Section of the wooden louvers shows the simple manner in which they were made and assembled. Drawing: Thomas Vitanza

The louver frame was designed to fit snugly into the existing sash tracks and simultaneously to secure the glazed upper sash. An added benefit of the 6" stock width is that it provided a fairly rigid — and thus secure — louver frame. The louver frame was constructed of 1" x 6" shelf grade northeastern white pine; the louver slats were

made from 1" x 8" pine (see figure 2). The spacing of the louver slats did not exceed 4" in order to provide additional lateral strength (and security) to the frame. The relative closeness of the slats also would make it more difficult to kick out the grade level units. The slats were set into the frame at a 45 degree angle by routing a 1/4" deep dado

cut into the jamb of the louver. The exposed edges of the slats were plumb cut in order to create a water drip on the exterior.

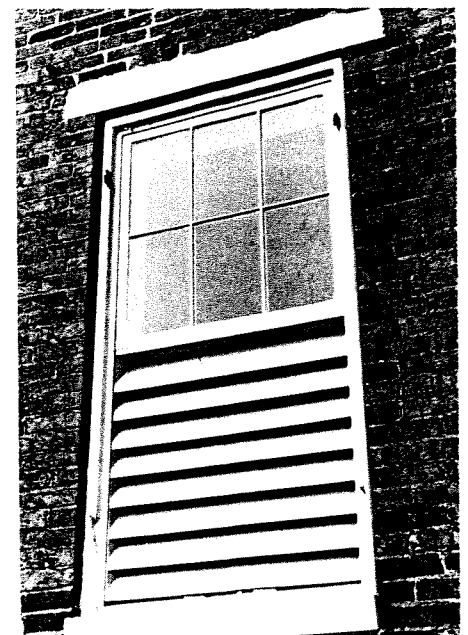
Figure 3. The exposed edges of the louver slats were plumb cut in order to create a water drip on the exterior. For aesthetic reasons, the louvers were painted the same color as the sash and trim. Photo: Charles Fisher

Prior to assembly, the louver members were primed using an alcohol base paint in order to get at least one protective coat on all surfaces. After assembly, they were given one shop coat of oil base exterior house paint. A final coat was applied after installation. For aesthetic reasons, the paint color used on the sash and trim was selected for the final coat on the louvers (see figure 3).

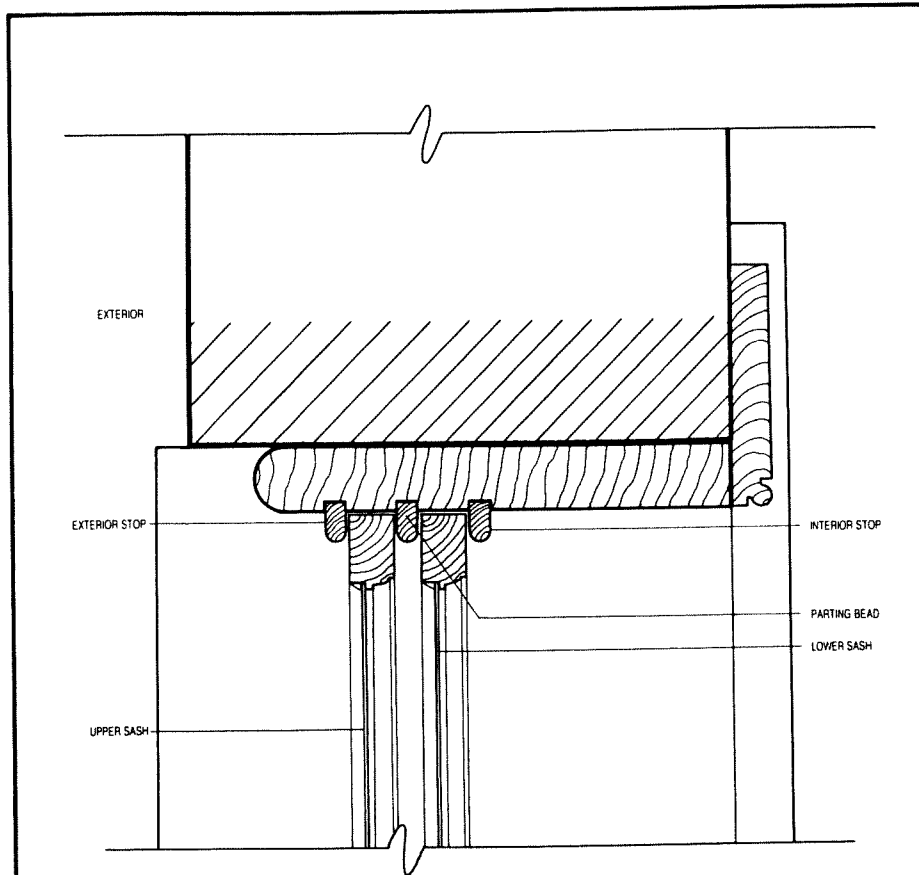
FIG 4A. EXISTING WINDOW JAMB PRIOR TO LOUVER INSTALLATION

Figure 4. The lower sash (Figure 4a) were removed to permit installation of the louvers. To minimize damage to historic fabric in installing the louvers, temporary blocking was set between the parting bead and stops prior to nailing the units in place (Figure 4b). Drawings: Thomas Vitanza and Christina Henry.

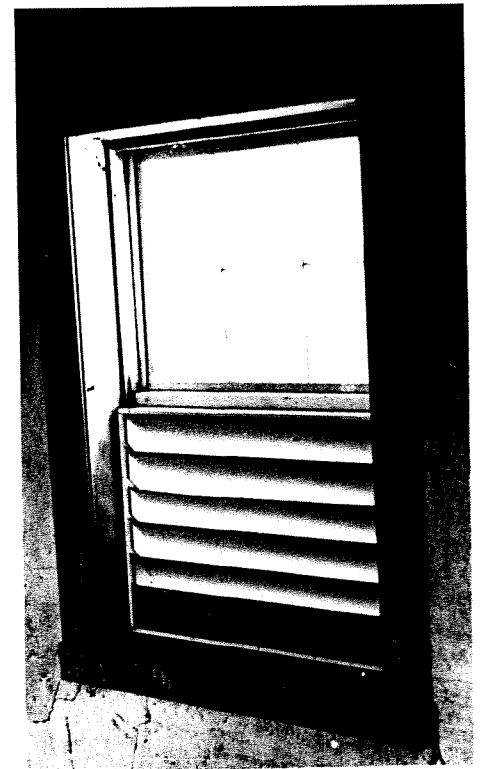
Figure 5. Screening was attached to the back side of the louvers to prevent the recurrence of insect, bird, and rodent infestation. Photo: Charles Fisher

After the louvers were secured in place, $\frac{1}{16}$ " mesh copper wire screening was installed on the interior of the louver frame using a $\frac{1}{2}$ " square wood frame. The screening is an integral part of the louver design. This seemingly minor detail was necessary to prevent the recurrence of insect, bird, and rodent infestation (see figure 5). The $\frac{1}{16}$ " mesh was specified to keep out the ever-present mud-dauber wasp, whose hive-building instincts have no regard for historic plaster or paint.

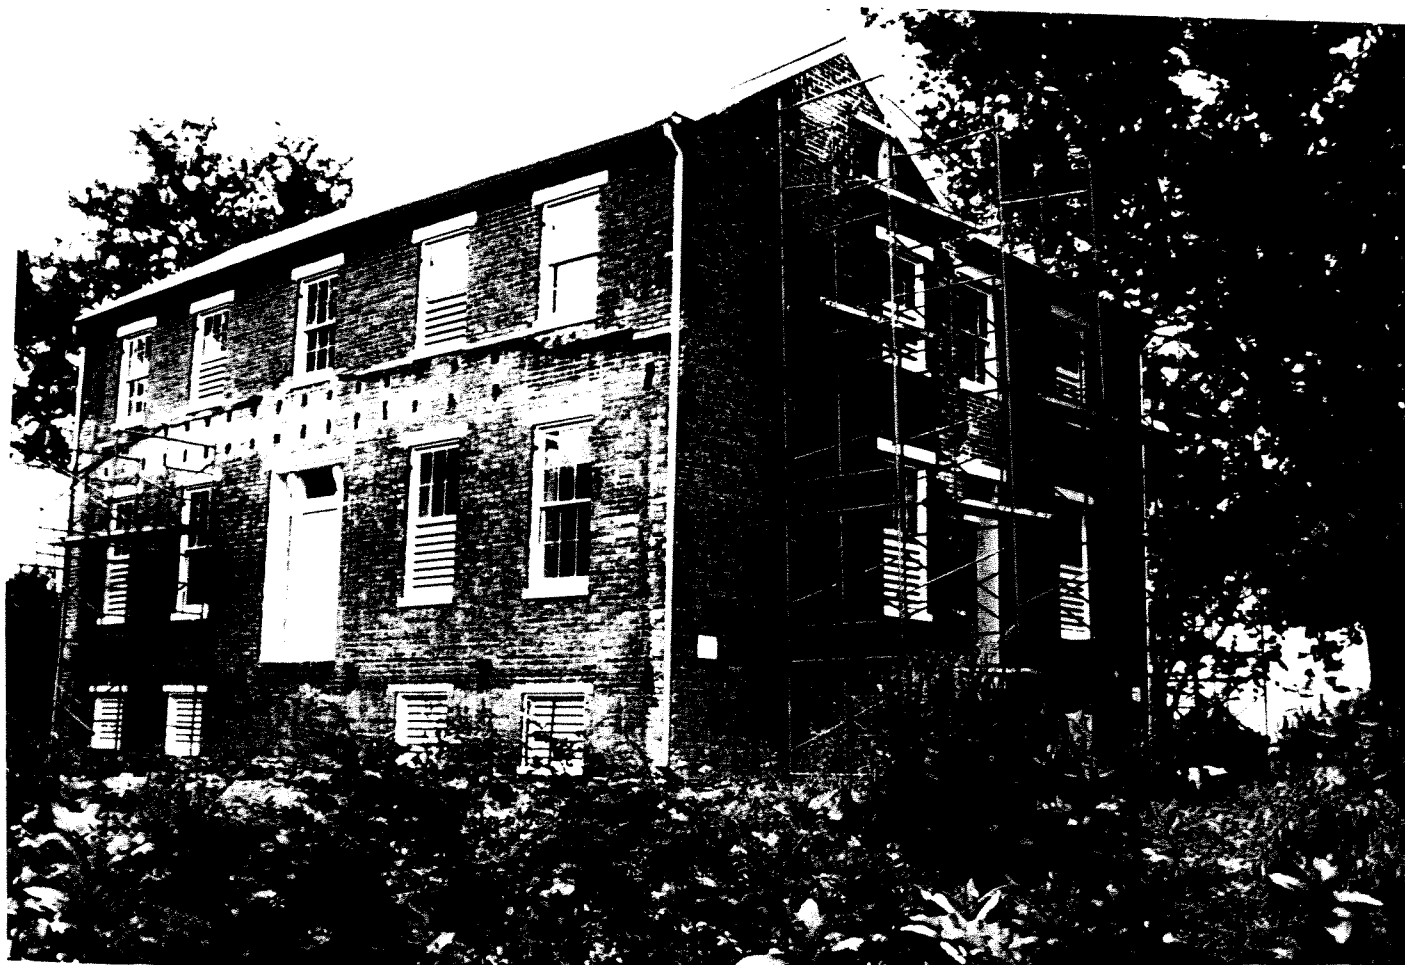
The window louvers installed in the Worthington House have proven effective over the past two years in providing the necessary ventilation for the building (see figure 6). Neither fungal attack nor condensation damage has recurred, and the interior air lacks even the typically humid, musty odor typically found in many older buildings. The louvers provide for good air movement within the building and a greater equilibrium between interior and exterior humidity levels and air temperatures, thus helping to protect the historic plaster and the significant interior finishes. The installation of the louver system in conjunction with the other sash work, and the overall exterior stabilization work has stimulated an interest in finding a use for the structure. As a temporary solution to a complex set of problems, the louver vents in the Worthington House have resolved a variety of issues. When used together with additional weatherproofing measures, this venting solution can be adopted for use in other buildings being mothballed.

Figure 6. The window louvers installed in the Worthington House have proven effective over the past two years in providing the necessary ventilation for the building. Photo: Tom Vitanza.
