WINDOWS NUMBER 10

Temporary Window Vents in Unoccupied Historic Buildings

WORTHINGTON HOUSE Monocacy National Battlefield Frederick County, Maryland

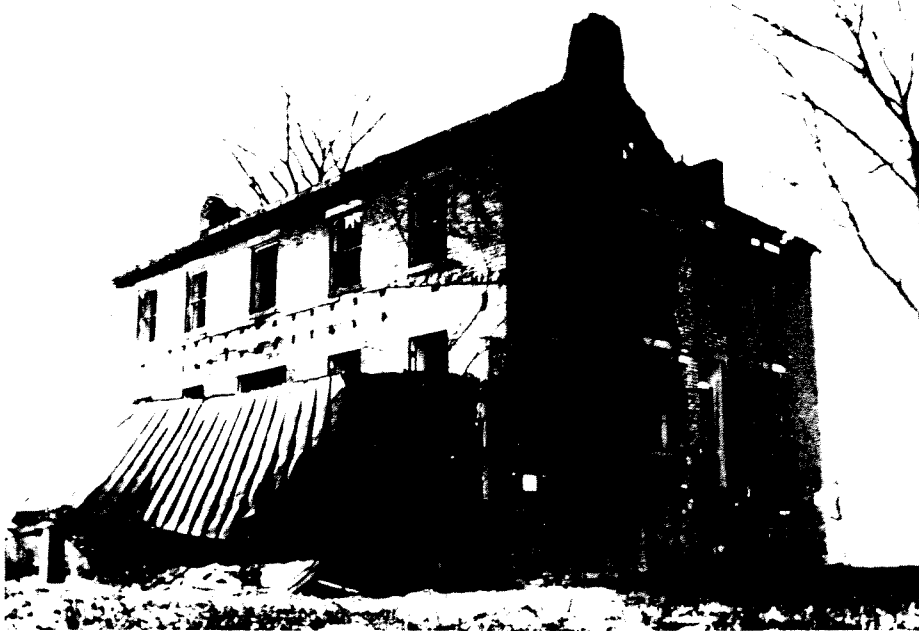
Figure 1. Full louvered vents were installed in all single-sash openings in the basement because of the more severe moisture problems present in that location. Photo: Charles Fisher
